Massachusetts Historical Commission Massachusetts Archives Building

Address 23 Lincoln Street

Historic Name William Hannam House

### BUILDING FORM (23 Lincoln Street)

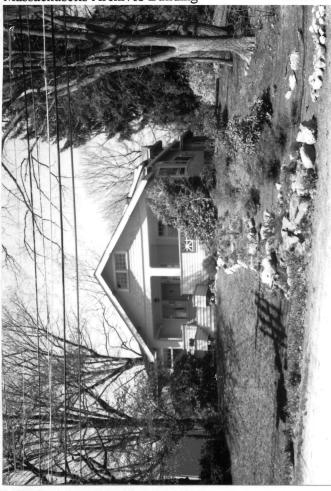
A good example of an early 20th century bungalow, 23 Lincoln Street (MHC #1074) is a 1 1/2-story, wood shingled dwelling which rests on a stone foundation laid with a distinctive raised bead joint. Typical of the style, the house displays a gently-pitched, broad gablefront. The overhanging eaves are decorated by exposed rafters and at the top of the gable is a horizontal pair of 4 x 3-light windows. The front gable shelters an open porch which is divided into two bays by square posts which are spanned by a horizontal beam which curves at the top of the posts. The posts rest on a shingled wall which is punctuated to the east by an inset star balustrade. The wooden front stairs are flanked by shingled sidewalls resting on a stone foundation.

Facing the house, the entrance is to the left and contains a wooden door with two raised panels, flanked by two 6/1 windows with molded surrounds. To the right is a large picture window consisting of a large single-pane window with a 6 x 2-light transom, set in a tapered surround. A similar picture window is located to the left of the projecting front porch and is supported by paired brackets. Fenestration on the side elevations includes a band of three 3 x 4-light windows on the west side and a three-sided bay window with 6/1 windows on the east.

Behind the original house is a large wood-shingled addition constructed in 1989. Fenestration includes casements, sliders and 1/1 sash. A porch on the west side echoes the front porch and displays a similar overhang with exposed rafters.

The house is set above the level of the street. A paved path leads up from the street and mature sugar maples shade the front yard. Behind the house is a wood-shingled garage (MHC #1075), oriented with its gablefront facing Audubon Road. The garage is notable for retaining its double accordion doors. Each of the six panels consists of a 2 x 2-light upper glass over two recessed vertical panels.
